TECHNICAL FEATURE

Energy Audits, Improvements In Small Office Buildings

By **Ian M. Shapiro, P.E.**, Member ASHRAE

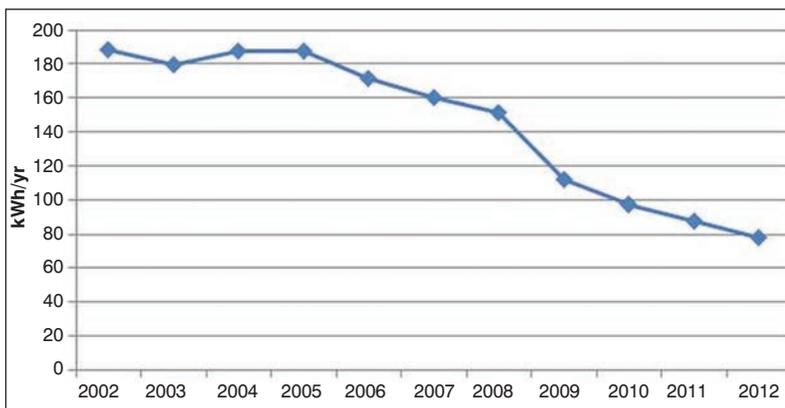
Figure 1: Total energy use at a small office building at 109 S. Albany St.

The total reduction in energy use is significant: a 60% reduction over the 10 years, on a basis of total energy usage (*Figure 1*, Page 20).
